## Characterization of elements of the wood exploitation of *Pinus maestrensis* Bisse in "El Franco", Guisa

The study was carried out in the area of "El Franco", Guisa municipality, Granma province, Cuba. The objective of the research was to characterize elements of the operations in the forest exploitation of the species *Pinus maestrensis* Bisse. Information from the database of the forest management project of the Empresa Agroforestal Granma, a Digital Terrain Model and an Integrated Geographic Information System for Forest Management were used to calculate the density of the road network. Through field observation, the organizational collection system was classified and extraction, collection and loading activities were described. The result was that the area has a road network composed of 23,3 km of 1<sup>st</sup>, 2<sup>nd</sup> and 3<sup>rd</sup> category roads distributed in 35,7 %, 17,9 % and 46,4 % respectively with a total density of 41 m/ha<sup>-1</sup> and trails that do not fully comply with the geometric characteristics established for forest roads. The logging areas have a ring pattern, with the abandonment of commercial-sized logs and the use of wood handling tech

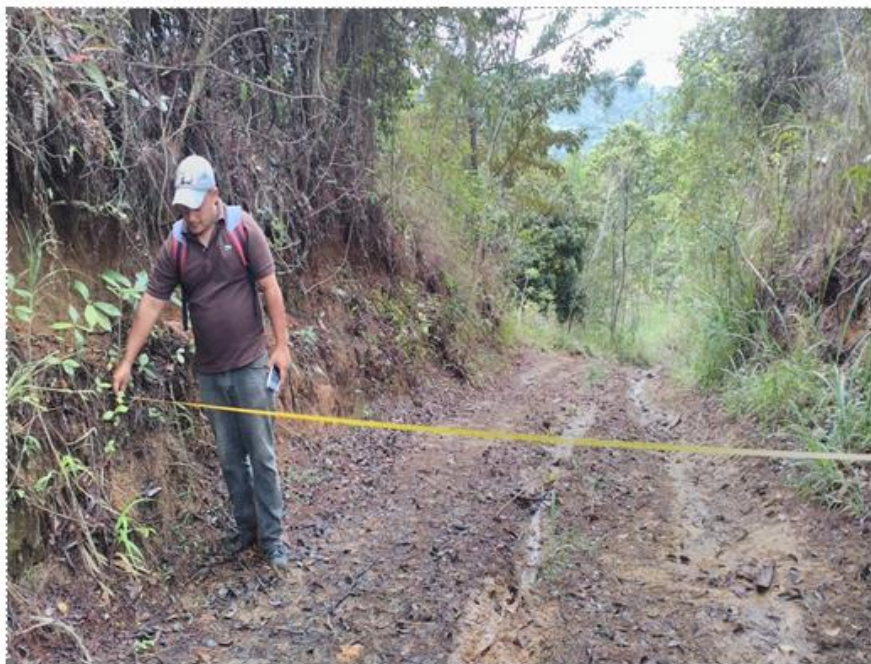
**Figure 2.** - Measurement on a third category trail

As can be seen in the diagrams represented in [Cuban Standard 53-126, \(1984\)](#), with regard to design, the width of the crown is one of the geometric characteristics of roads that, regardless of their category, determines practically the entire width of the strip where they are located, since it includes other aspects such as the size of the roadway and the paths. In relation to this parameter, the trails analysed in the second and third categories have wider widths than those established by [Notario and Rodríguez \(2007\)](#), since the width of the crown exceeds the range established by these authors for these categories by 1,5 m and 2 m, respectively, to the range established by these authors for these categories, they have an average width of 6 m (Figure 2) which is also over-dimensioned compared to the widths stipulated in the [Norma Cubana 53-126, \(1984\)](#).

Specifically, for the third category roads the authors **García and Vidal, (2016)** establish that they should maintain values of 3,0 4,0 m wide, however, the measurements made showed a minimum value of 3,50 m and a maximum of 10,35 m which negatively influences the structure of the same bringing about an increase in unnecessary erosion within the logging areas.

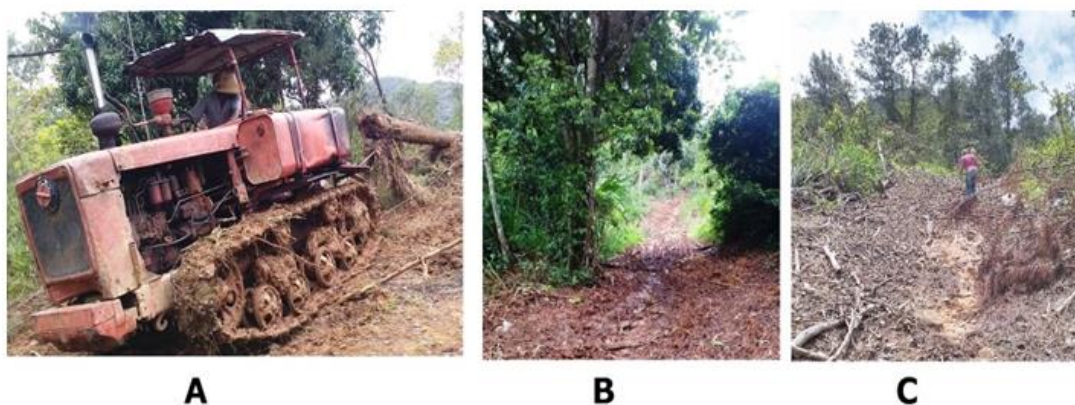
The lack of knowledge about the importance of soil conservation, the lack of training in reduced impact techniques, as well as the absence of a thorough inspection are parameters that act against the minimization of soil compaction and alteration caused by this work. Figure 4 shows how these alterations were manifested in the extraction routes, which were also influenced by the severity of the slopes.

**Figure 4.** - Effect of entrainment by extraction operations with DT 75

Timber extraction always generates deterioration of the ecosystem. In the area of study, the effects caused to the soil by the dragging of the logs were manifested to a lesser degree by the use of draught animals and to a greater degree when combined with the use of tractors, since these rotated in different places, increasing the size of the affected area.

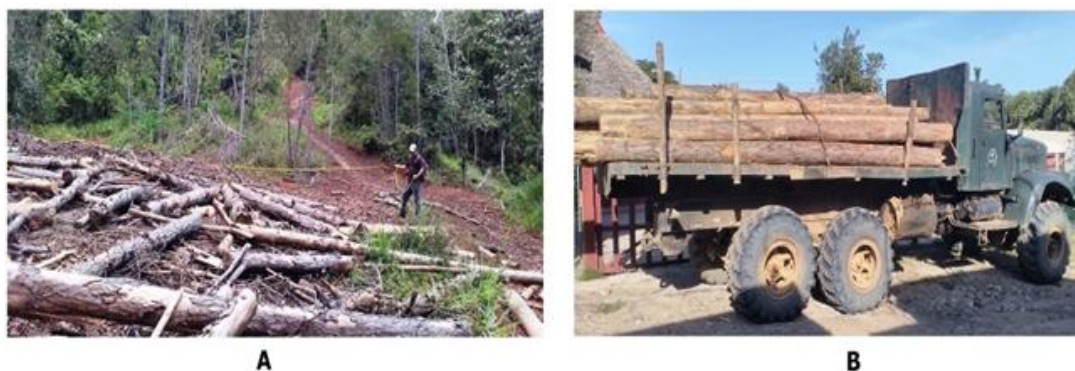
In these stockpiles there are still problems of organization and abandonment of logs of commercial dimensions, as shown in Figure 7 A (Figure 7).

**Figure 7.** - (A) Disruption and abandonment of commercially sized logs in the stockpiles and (B) KRAZ transport with large manually loaded logs

In the absence of the necessary equipment in the storage areas, the truck is loaded manually using techniques such as lifting with cams or rolling when the truck is located near a slope, which makes it easier for the bolus to roll by gravity and push it to the truck bed. This loading system is quite rudimentary and is designed for

smaller logs than those of *Pinus maestrensis* extracted from these forests, which reach up to 60 cm in diameter at the base (Figure 7 B). As an alternative, a semi-mechanized prop loading system could be used as illustrated by Garcia *et al.*, (2012), which would improve performance while being ergonomically more convenient. This system requires few resources for its implementation, is appropriate for moderately heavy or light logs and allows for the use of animal traction to lift the logs, which would facilitate the work and be objectively applicable since mechanised loaders are not available.
